AIRCRAFT ACCIDENT REPORT

UNITED AIR LINES, INC.

Boeing 737, N9031U

REPORT NUMBER: NTSB-AAR-73-16

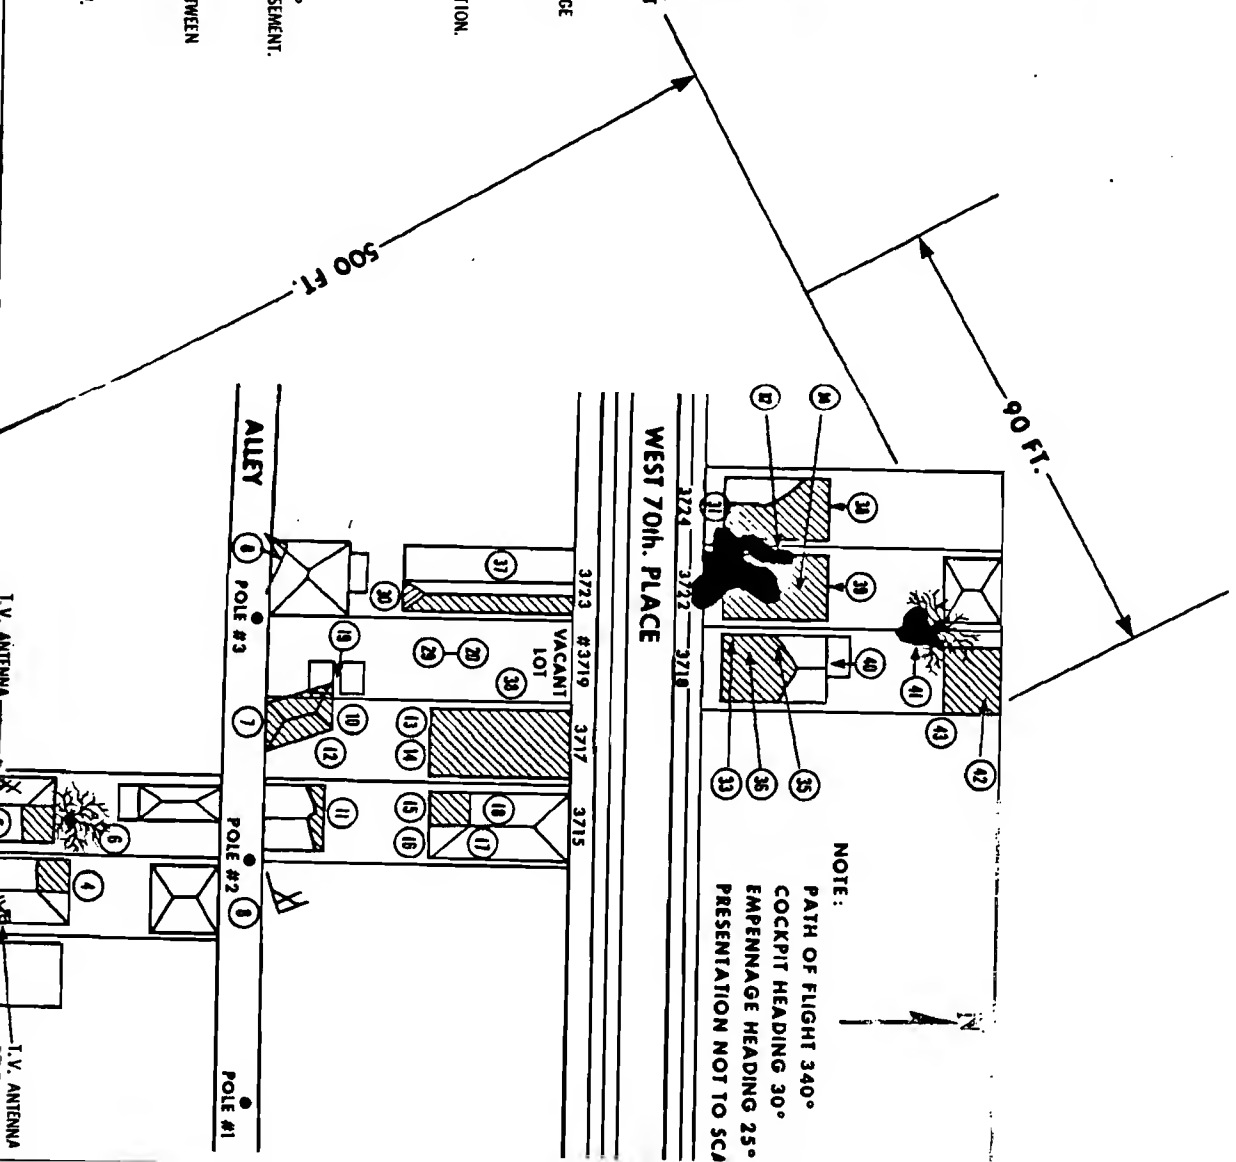
- 17 SOUTHWEST CORNER OF HOUSE DAMAGED.
 - 18 SECTION OF RIGHT WING LEADING EDGE FOUND BETWEEN HOUSES.
 - 19 SECTION OF LEFT HORIZONTAL STABILIZER.
 - 20 SECTION OF FLAP TRACK INCLUDING JACK SCREW.

- 21 SECTION OF FLAP TRACK FAIRING.

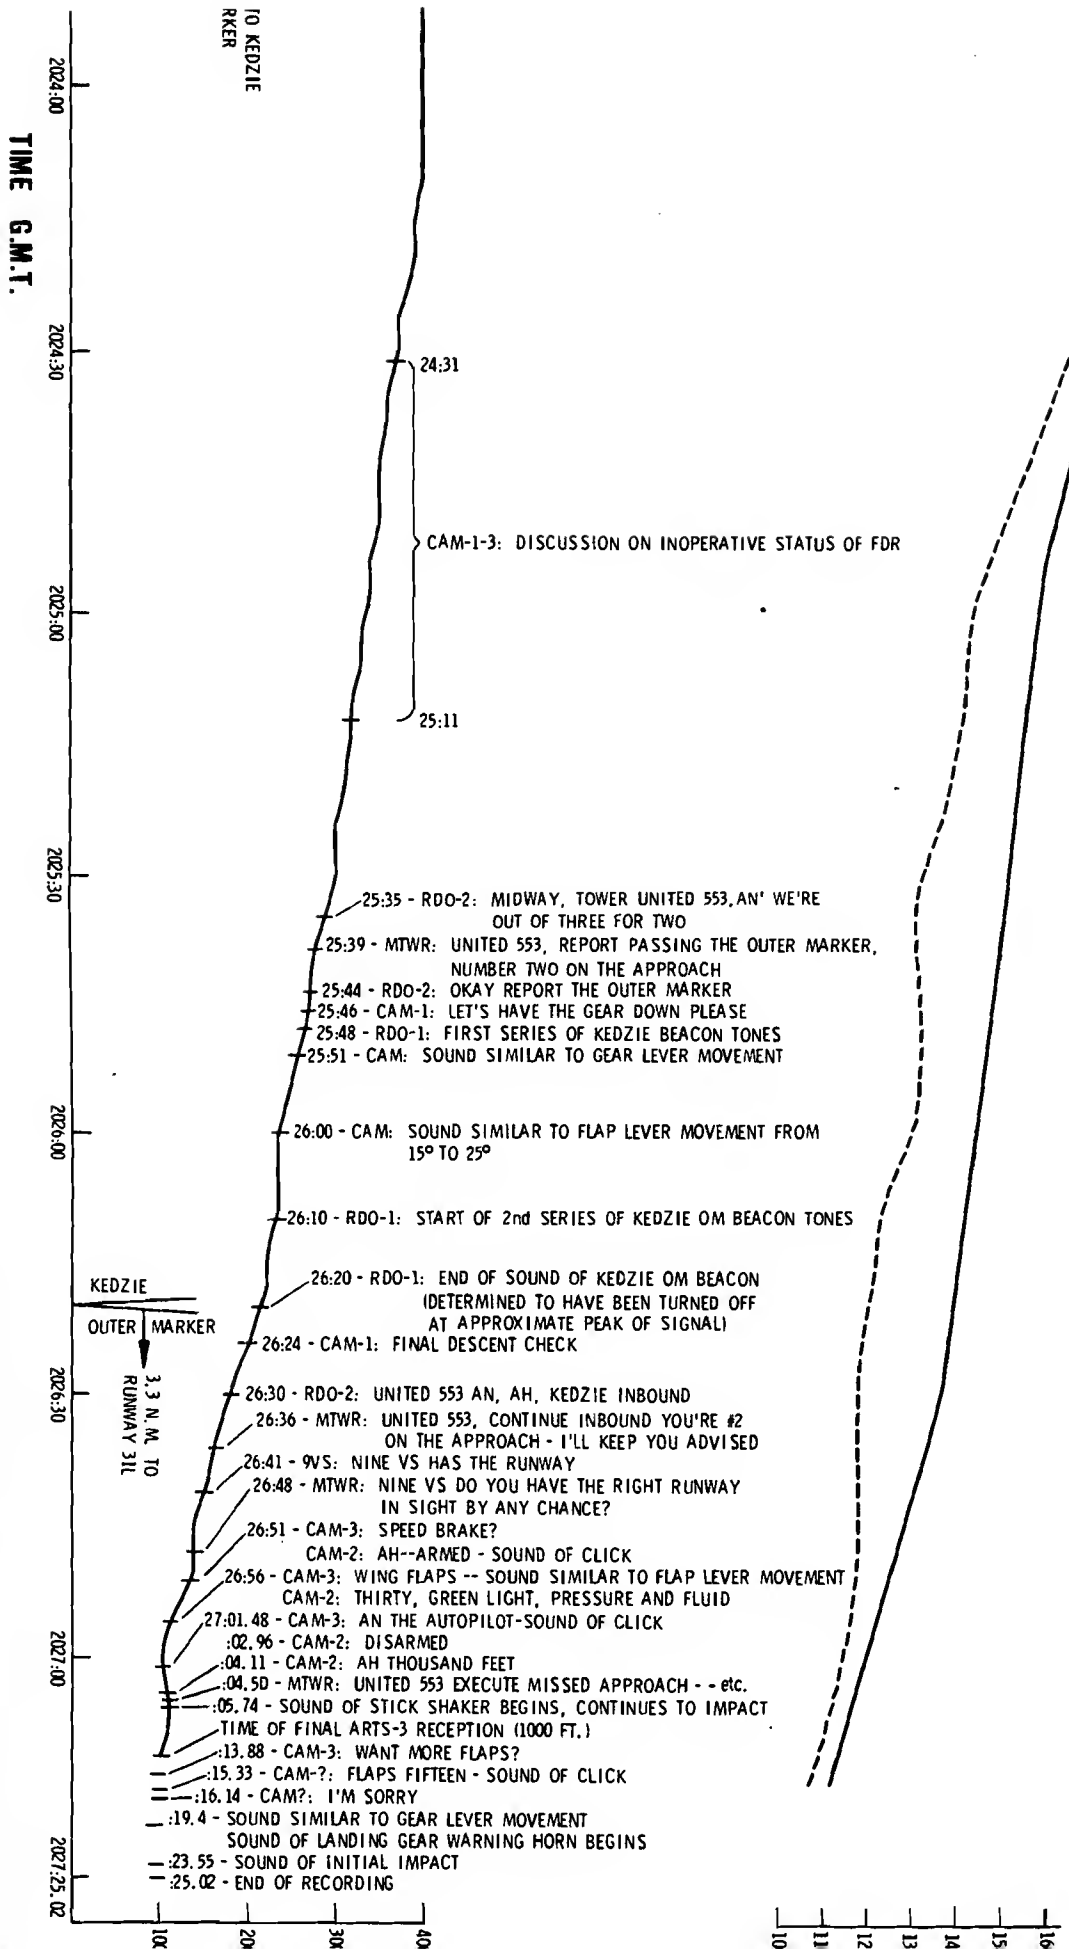
APPROACH PROFILE DERIVED FROM ARTS III AND CVF
UNITED AIRLINES, INC. B-737, N9031U, FLIGHT 553
NEAR MIDWAY INTERNATIONAL AIRPORT, CHICAGO, ILLINOIS
December 8, 1972

The cumulative effect of the crew's apparent failure to ascertain their position on the localizer course was that the flight crossed the Kedzie OM at about 2,200 feet m.s.l., 700 feet above the published minimum crossing altitude. The Kedzie beacon signal may have been the crew's first positive indication of their inbound position. At that time, the aircraft's distance from Runway 31L was 3.3 nmi which was equivalent to 1 minute 39 seconds flying time at an average ground speed of 120 knots. When he recognized the situation that was developing, the captain increased the rate of descent to approximately 1,550 ft/min and immediately called for the final descent check. The company's nonprecision approach profile indicated that this checklist was to be completed before crossing the OM. Testimony by company flight management personnel at the public hearing indicated that this procedure was not mandatory in a nonprecision approach and that it depended primarily on the distance between the final approach fix (OM) and the runway. Considering the short distance between Kedzie and Runway 31L, the captain's delay in calling for the final descent check does not appear to be a preplanned course of action on his part. The resulting increase in the cockpit workload and disruption of crew coordination during the most critical phase of the approach turned out to be key elements in the development of the accident sequence.

4 seconds of reaching level-off altitude. The 1,500 ft/min descent from the outer marker to the MDA was in excess of that recommended in the company's operations manual.
